November 17, 2014

Re: Asbestos Survey 928, 932, & 938 Broadway Ave., and Adjoining Alley Building, Lorain, Ohio

At your request, on Monday, October 27, and Tuesday, November 11, 2014, HazCorp Environmental Services, Inc. performed an asbestos inspection at the above-referenced properties.

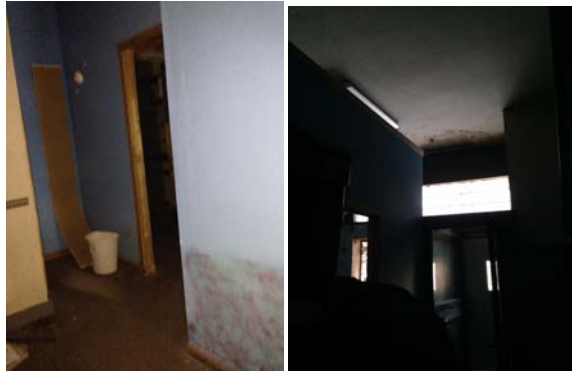
Back area of 932 – drywall-joint compound is ACM.

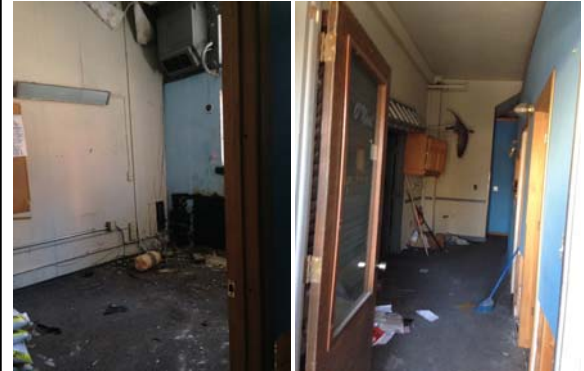
Back area of 932 – drywall-joint compound is ACM.

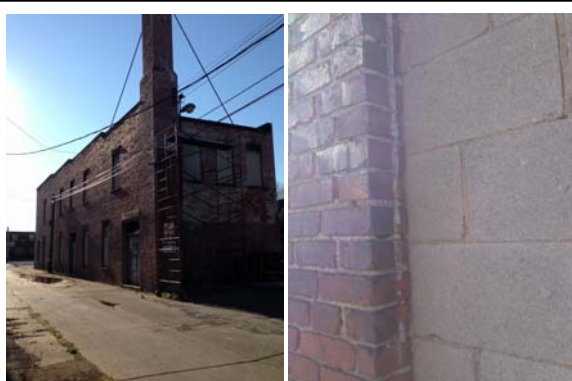
Alley building (left). ACM caulk on the alley building (right).
